SITE INSPECTION ML 47287

Lease #: O,G & H, ML 47287

Black Sands ML47287

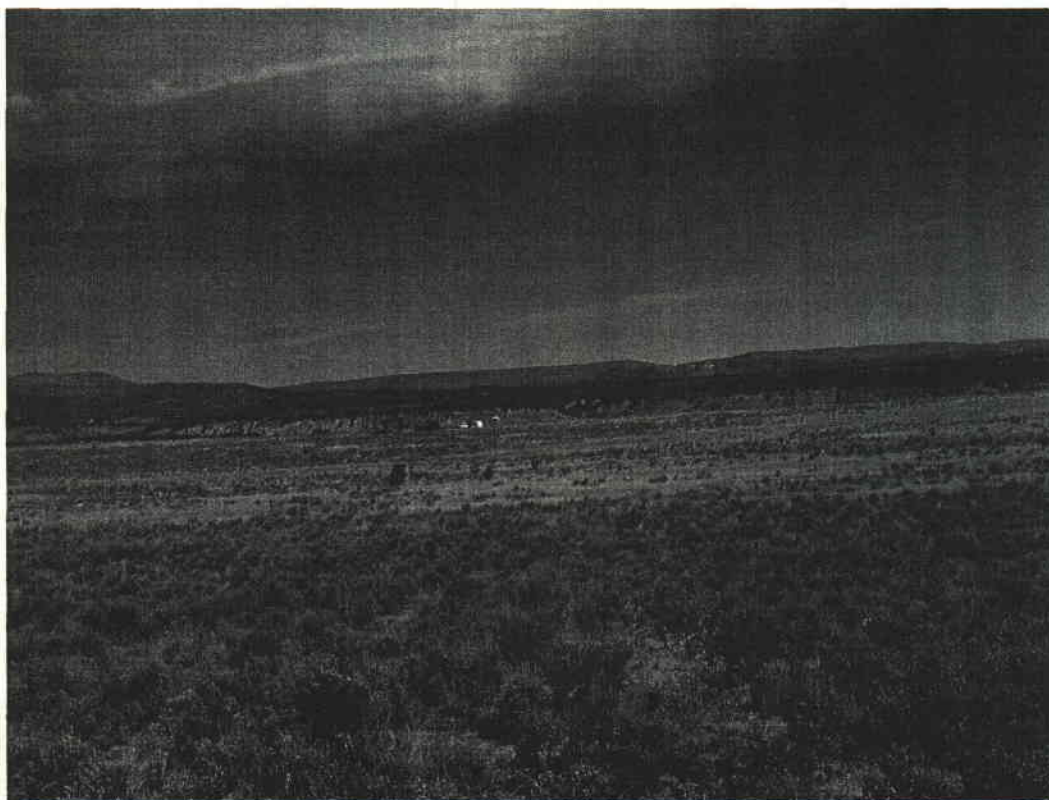
ML 47287, 6-1-06 Looking north from a proposed drill location as identified in the Notice of Intent. In the distance is the processing facility.

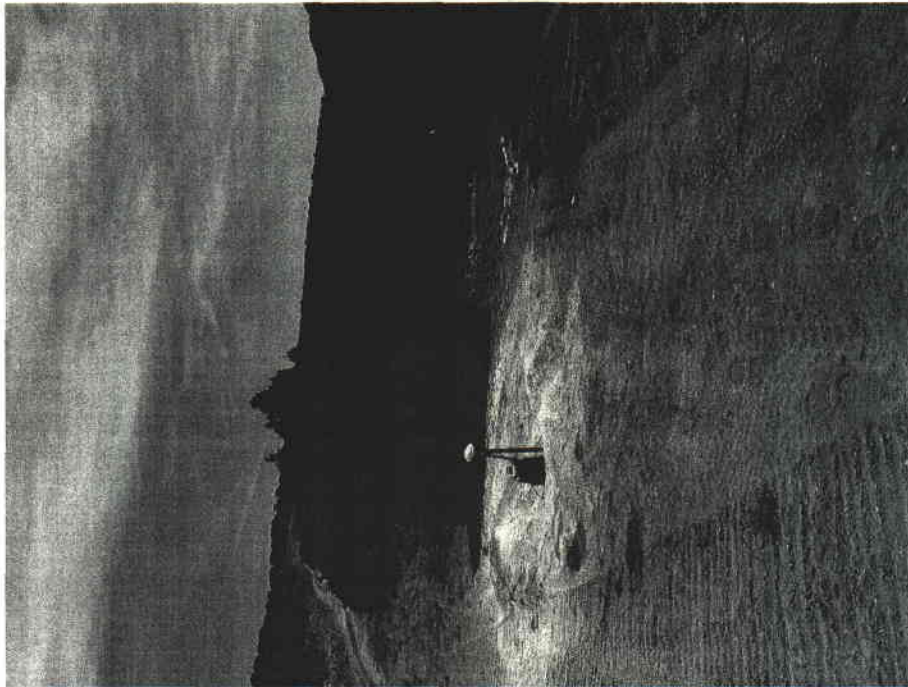
ML 47287, 6-1-06 Looking east onto a drill hole that is identified as "Drill Point # 4"
 This road is located in the SW $\frac{1}{4}$ of Section 23 and is not shown on the topographic map.
 The UTM coordinates for this drill hole is: N 4478729.74, E 614415.06. Just west of this
 location the road has been blocked off with a pile of dirt.

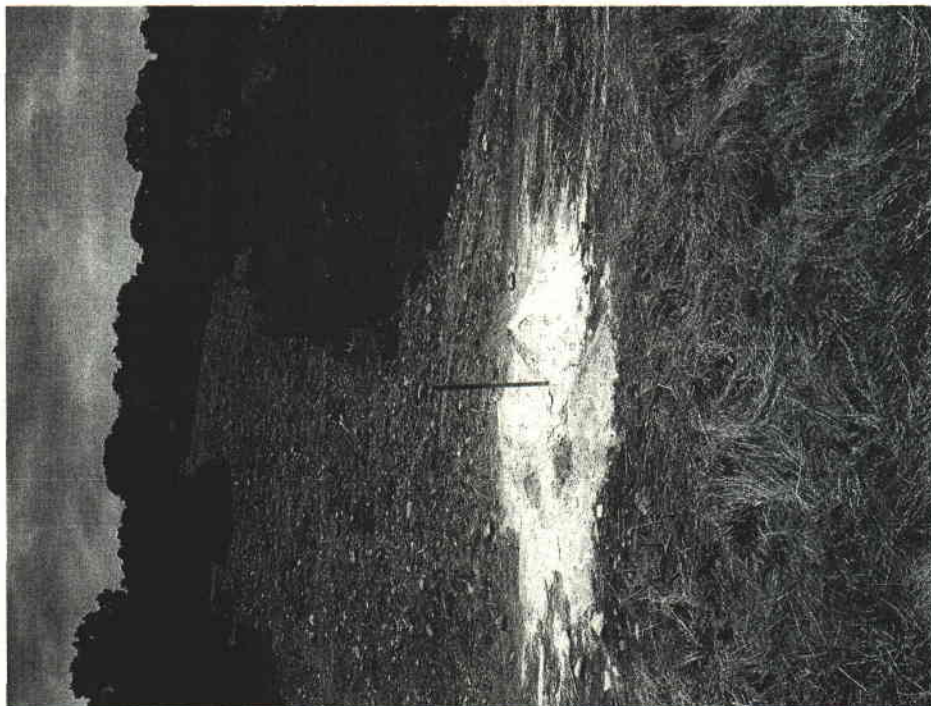
ML 47287, 6-01-06 This drill hole is located in the NW $\frac{1}{4}$ NW $\frac{1}{4}$ of Section 26. The lath
 has no identifying information on it. The UTM coordinates are: N 4478081.14, E
 614689.80

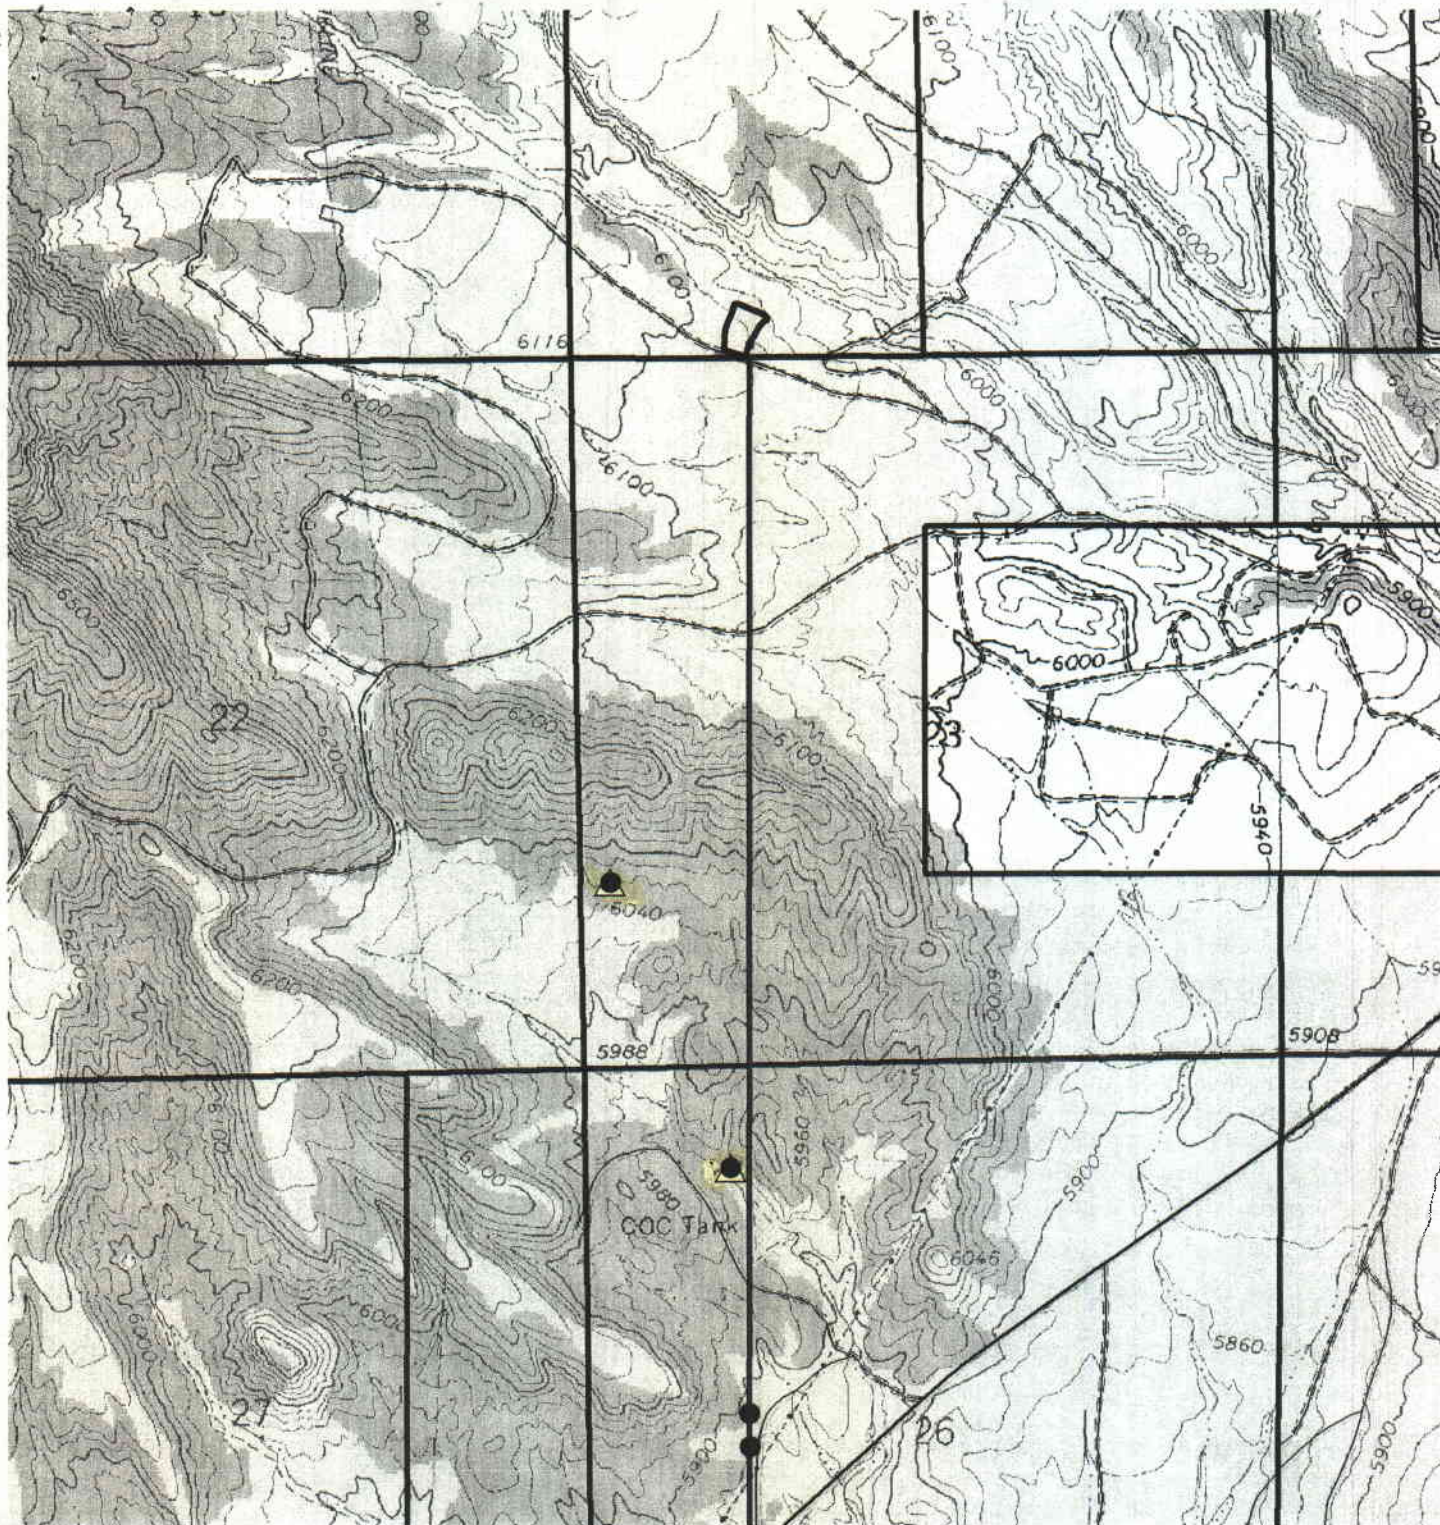
*Holes drilled in not permitted area
See photos & maps*

*Southern 2 Drill holes
were not visited & not GPS'd*
